PALM STREET WATER PLANT CONDITION ASSESSMENT

City of Huntsville

July 31, 2015

FREESE AND NICHOLS, INC.
11200 Broadway Street
Offices West, Suite 2332
Pearland, TX 77584
832-456-4700

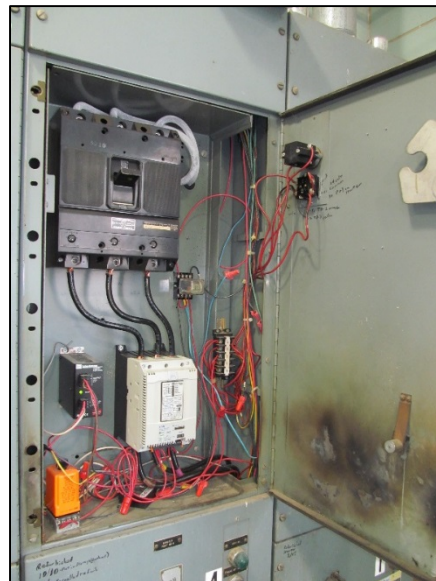
3.1.2 MCC

The Motor Control Center (MCC) was installed in the 1960s, has passed its life expectancy of thirty years, and is no longer supported by the manufacturer. Individual MCC components will no longer be available after they fail. Parts are replaced with comparable components that will fit within the shallow buckets and safety clearances are compensated to get the equipment into working conditions. Wiring inside the MCC is insulated with cloth, which loses its protective properties over time and subjects the equipment to faults. Past faults are evident within the MCC by the indications of carbon deposits on the interior walls. Inside the MCC are water lines used to monitor the tank water level. Water pipe installed inside electrical gear is no longer a good practice because of the ramifications of water leaking on electrical wires, busses and components.

Score	Rating
Condition	4	Poor Condition
Criticality	5	Very High Impact
Risk	9	High Risk

Recommendation: Replace wiring and the MCC.

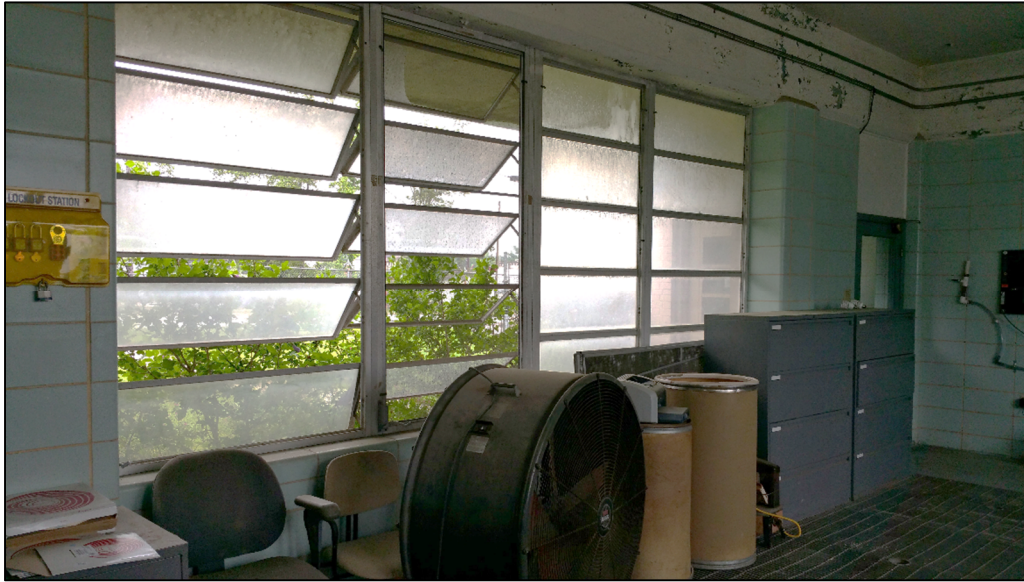
The HVAC in the old pump station consists of a single thermostatically controlled gas-fired unit heater for freeze protection, a floor portable rolling fan to circulate air, and operable windows. The single unit heater is in good condition, but the lack of redundancy and the lack of a permanent ventilation system lead to the overall HVAC condition being considered poor. The pump station has operated without a permanent mechanical ventilation system since it was built, so the impact of the lack of a ventilation system is low.

Score	Rating
Condition	4	Poor Condition
Criticality	2	Low Impact
Risk	6	Moderate Risk

It is recommended that a second unit heater be added to the space for redundancy, to ensure that if one unit heater fails, the other can protect the space from freezing. It is also recommended that a dedicated mechanical ventilation system be installed. Although the pump station has been operating without one, a dedicated mechanical ventilation system would help increase the motor life by preventing overheating. Installing this system would involve removing a section of windows on one side of the building, and replacing it with a motorized combination louver/damper for air intake. On the opposite wall, a wall-mounted propeller exhaust fan would be installed for cross ventilation. The fan would be controlled by a thermostat so that when the room reached a certain temperature setpoint, the fan would turn on, the damper would open, and the system would ventilate the space until the setpoint was reached.

Recommendation: Install wall mounted exhaust fan, combination louver damper, and gas fired unit heater.

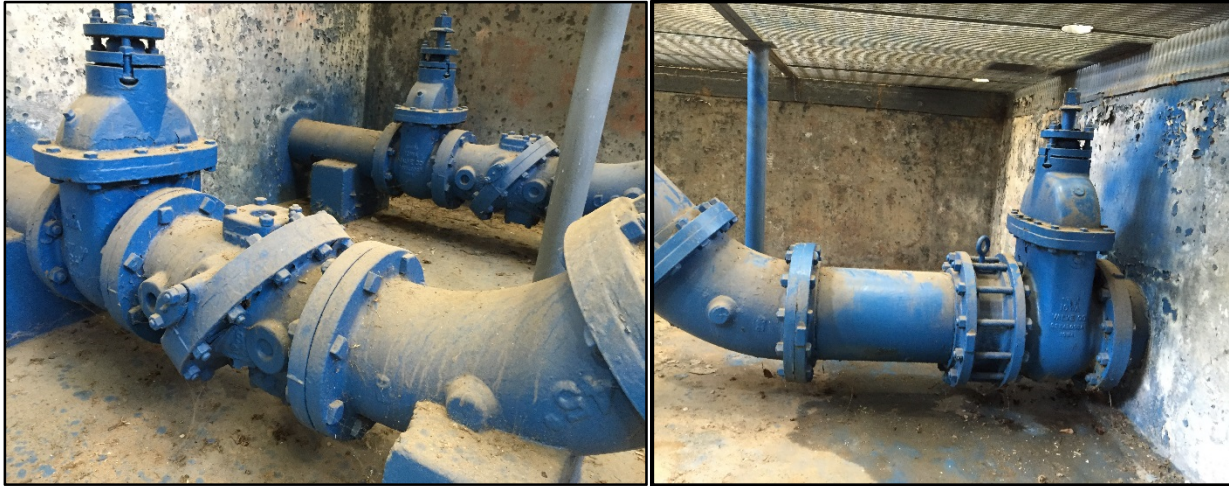
The piping at the Old Pump Station is original though it has been recoated since the original installation. The piping itself is in good condition but the coating has begun to crack and peel in some places. The pipe is made of ductile iron and will corrode if the coating is not repaired. The piping for the two larger pumps (Pumps 3 & 4) is not supported at the bends and valve the way the smaller pumps (Pumps 1 & 2) are supported.

Score	Rating
Condition	3	Fair Condition
Criticality	2	Low Impact
Risk	5	Moderate Risk

Recommendation: Replace aboveground piping.

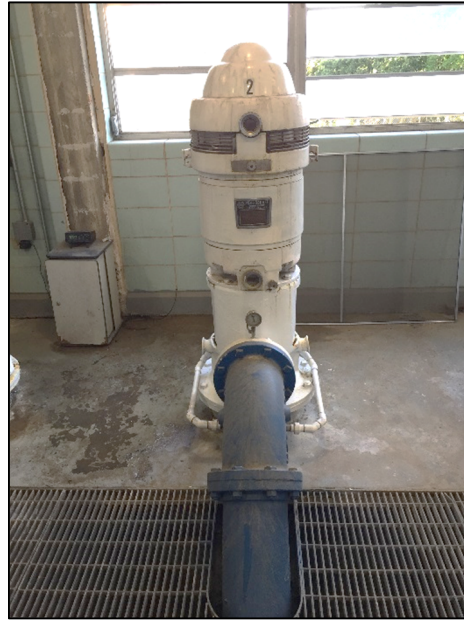
The pumps are Layne 12WMC and 12THC pumps originally installed in 1960. Each pump is in a different condition, but for the purposes of this report the overall condition has been given a 'poor' rating. Specifically, Pumps 1 & 2 are in poor condition, Pump 3 is in fair condition, and Pump 4 is in very poor condition. Below is a list of the notable issues with each pump.

- Pump 1
 - The discharge head is in good condition.
 - The coupling guard could not be removed.
 - The highest vibration reading is 0.918 in/sec rms, or seven (7) times higher than the HI limit.

- Pump 2
 - The discharge head is in good condition.
 - The coupling guard could not be removed.
 - The highest vibration reading is 0.297 in/sec rms, or two (2) times higher than the HI limit.

- Pump 3
 - The discharge head is in good condition.
 - The stuffing box is severely corroded and it appears the packing gland studs are gone.
 - The packing gland was not perpendicular to the shaft

- The highest vibration reading is 0.189 in/sec rms, slightly higher than the HI limit.
- Pump 4
 - The discharge head is in good condition.
 - The stuffing box is severely corroded and it appears the packing gland studs are gone.

Generally these pumps are seeing vibration well above the recommended Hydraulic Institute (HI) limit. The vibration was tested by Smith Pump Co. and can be seen in Appendix C. The coupling guards are recommended to be replaced due to the difficulty in accessing the pump shaft. Visual inspection of the pump shaft indicated significant corrosion as well as a leaking seal. The hydraulic results from the pump tests were not realistic due to the non-ideal placement of the strap on flow meter. There was no straight section of pipe with adequate length available to obtain an accurate flow reading. Since these pumps are original and given the observed corrosion and vibration issues, it is likely that the pumps are not running very efficiently. Additionally, any cast parts are not likely to be available if a repair is needed.

Score	Rating
Condition	4	Poor Condition
Criticality	4	High Impact
Risk	8	High Risk

Recommendation: Replace all four pumps, due to age and unavailability of cast parts.

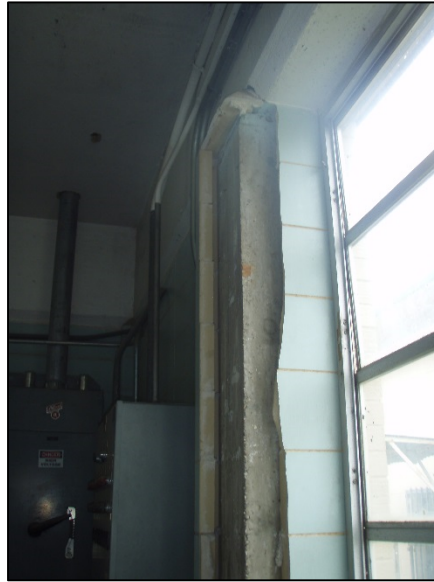
No signs of distress in the concrete beams and columns was observed.

Score	Rating
Condition	3	Fair Condition
Criticality	3	Moderate Impact
Risk	6	Moderate Risk

Recommendation: Replace broken glazed tile and repaint.

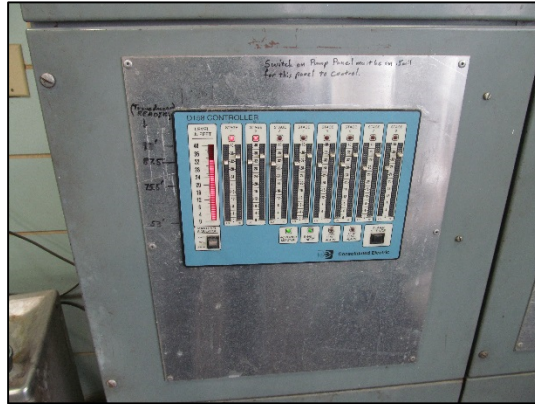
A pump controller is mounted to the front of an MCC door and is an older technology. The pump controller is used to automatically control the pumps based on level in the tanks. The manufacturer no longer supports the current controller and past repairs required the plant to send the controller to a third party repair service. The company supporting repairs has recently stopped repairing similar controllers for the lift stations. A manual control panel for the old and new pump station is located near the MCC and the pushbuttons, lights, and wiring needs to be updated for proper documentation. Over the years, repairs and modifications have not been documented and future repairs can become problematic to troubleshoot.

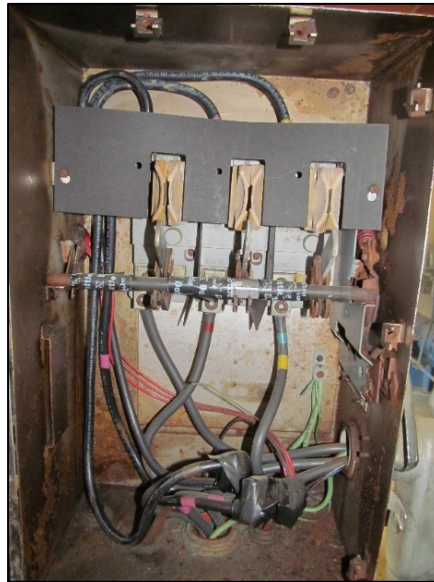
3.2.2 MCC

The Motor Control Center (MCC), installed in the mid-1980s, has passed its life expectancy of thirty years and parts are not readily available. An infrared camera was used during the site visit and temperatures indicate the equipment is operating within manufacturers specifications. A few hot spots were detected at wire terminations which can be corrected by the City's electrician. Although the infrared camera is used to help determine the operating temperature of the equipment, failures can occur due to other protective characteristic changes due to age.

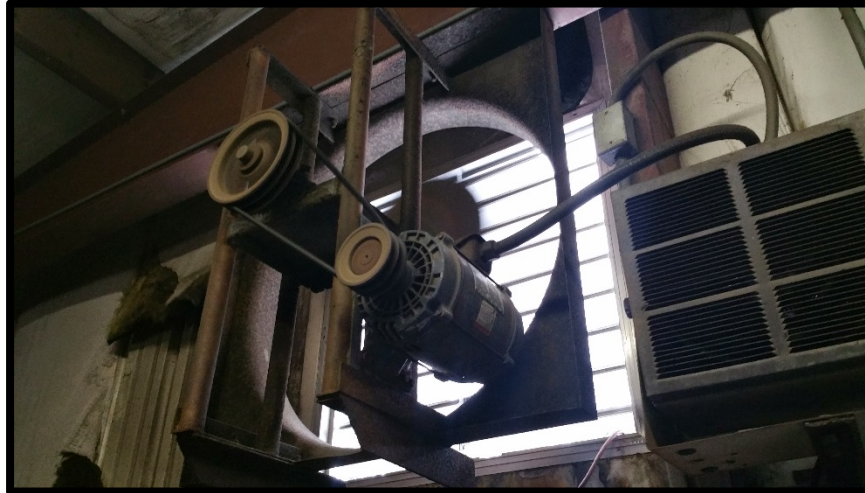
The current HVAC system consists of a wall-mounted propeller exhaust fan, two wall-mounted gravity dampers, and a single electric unit heater. The ventilation system in the new pump station is operable, but in need of repair.

The exhaust fan is nearing the end of its useful life and should be replaced. Included in the fan replacement, should be a wall-collar, OSHA guards, and a weatherhood. The gravity dampers in the doors allow water penetration and should be replaced with combination louver/damper rated for wind-driven rain. The electric unit heater, used for freeze protection in the space, is nonfunctional and should be replaced. It is also recommended that a second unit heater be added for redundancy; this would insure that if one unit heater was to fail, the other would protect the pipes from freezing.

It is recommended the exhaust fan should be replaced immediately. Also, the grille high in the wall should be replaced with a properly installed industrial grade wall-mounted louver.

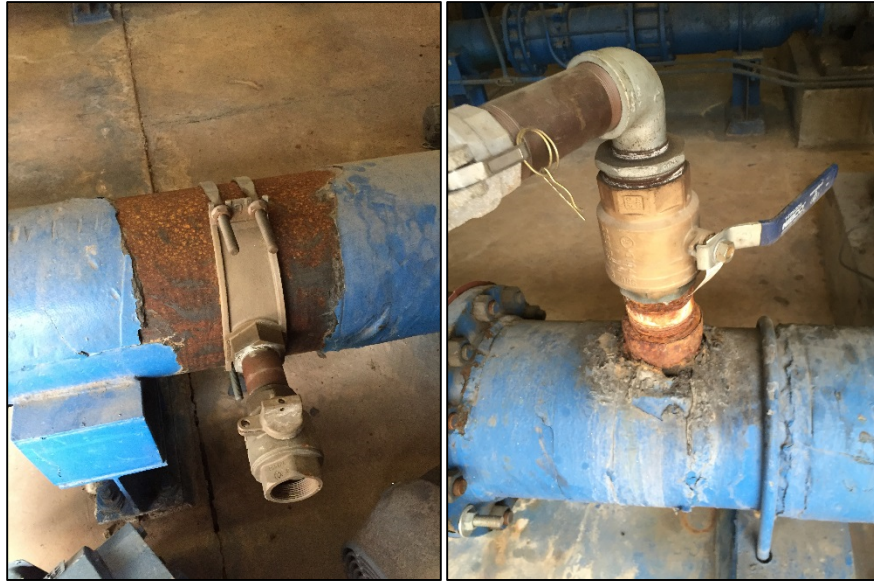
The piping at the new pump station is steel and is in fair condition. There are a few segments where taps have been made or other work done on the pipe that have removed the coatings and have allowed for significant corrosion, specifically on Pump 1. There are also a few sections of pipe that have been damaged as evidenced through visible dents in the pipe. The suction piping does not follow HI standards due to the eccentric reducer being located too close to the pumps.

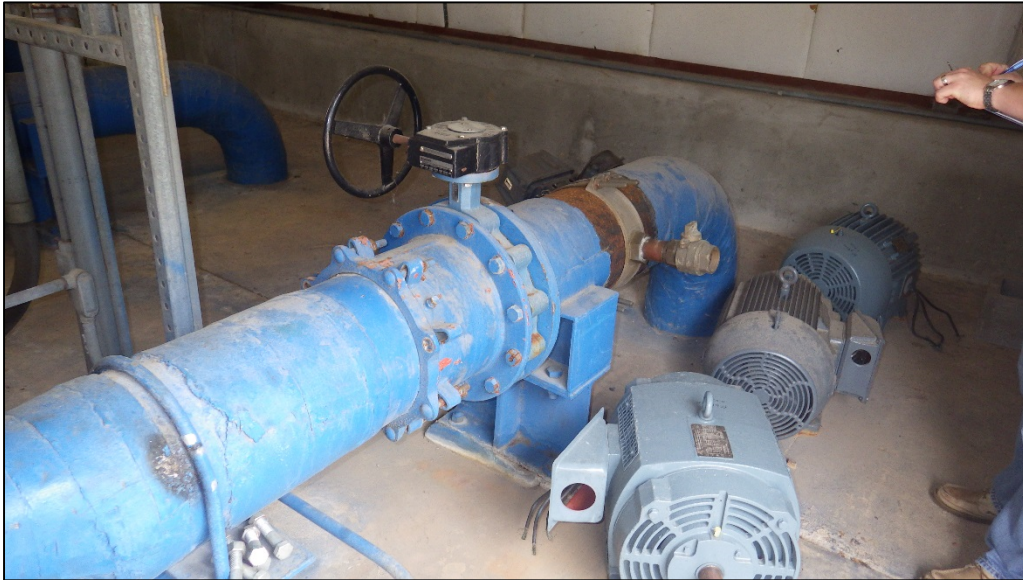
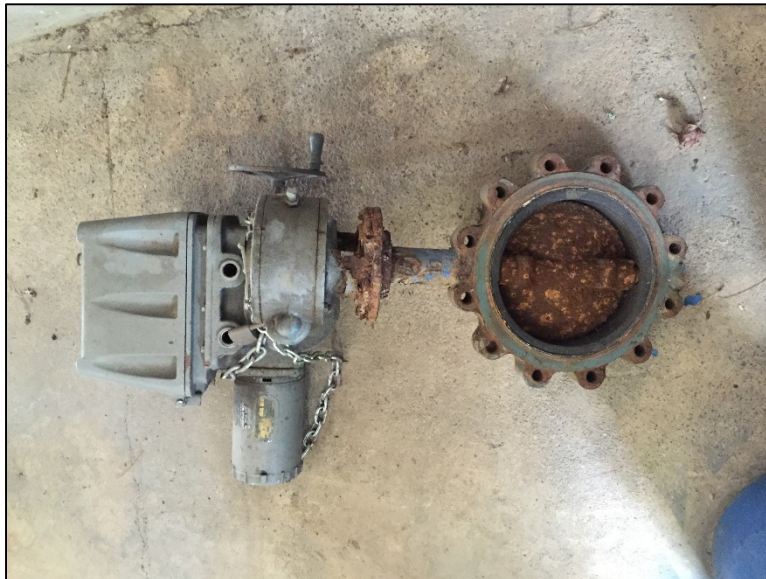
Butterfly valves are currently utilized for both the suction and discharge sides of the pump. Some noise was observed by the upstream butterfly valve, which indicates turbulent flow and the potential for cavitation. Additionally, an older valve that had been pulled was still on site and showed evidence of significant corrosion. Flow characteristics through the pumps could be improved if the upstream butterfly valves were replaced with a full port valve.

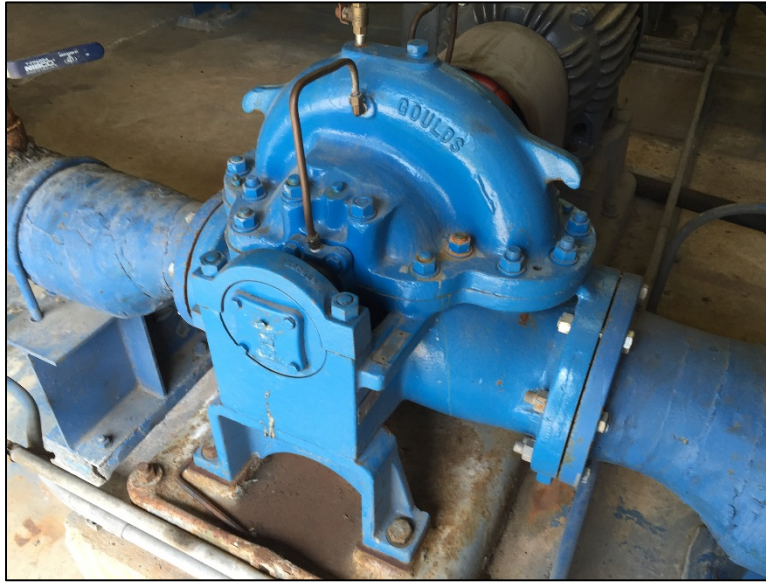
Plant operators have indicated that these pumps have given them more difficulties than the pumps at the Old Pump Station. It was noted by Smith Pump Co. that several of the pump alignments were off. Most of the pumps had low vibration except for Pump 4 which was close to the HI limit but still below it. Pump curves were not available for pumps 2, 3, and 4, though the hydraulic performance appeared to be close to the pump curve for Pump 1.

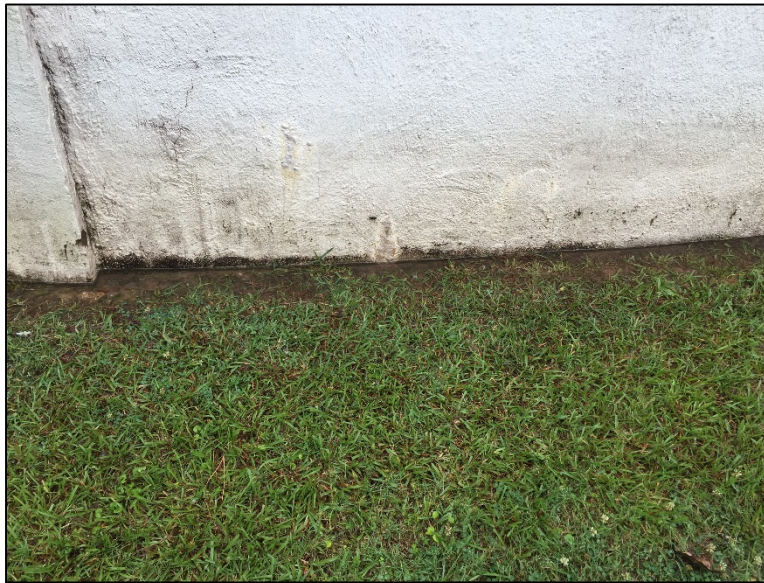
During the site visit it was observed that there was ponding in a few areas across the site, specifically, around the ground storage tanks and underneath the elevated storage tank. This is likely due to ground settlement after construction. While it does not appear to have caused any problems to date, it could allow for corrosion to begin at the base of the tanks.

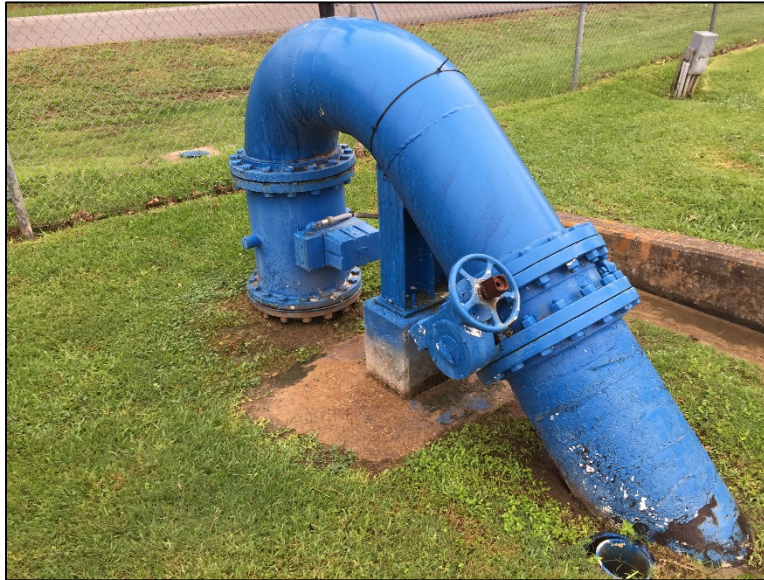
The flow meter on the discharge header of the New Pump Station is above ground in a vertical position directly downstream of a 135° bend. This does not meet the typical standard for mag meters which requires five upstream pipe diameters of straight pipe and 3 downstream pipe diameters of straight pipe. Relocating this valve to a straight section of pipe would provide more accurate readings for the flow coming from the New Pump Station.

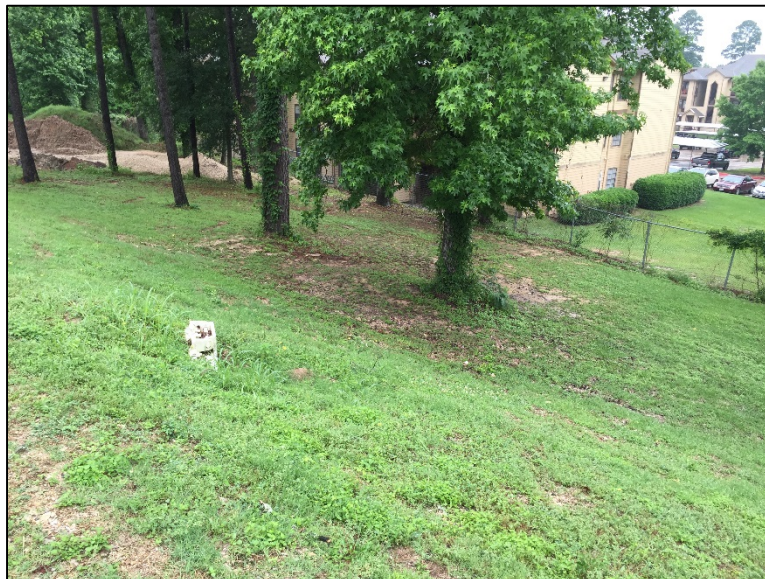
The existing tank overflows discharge on the north side of the plant on a slope away from the tanks offsite towards an apartment complex. Under normal circumstances any overflow water would still drain away from the apartment complexes but there is some risk of erosion on the slope. High flows or unforeseen circumstances may put the adjacent apartment complex at risk of flooding. The tank overflow piping could be extended to the northeast to discharge into the drainage ditch to mitigate this risk.

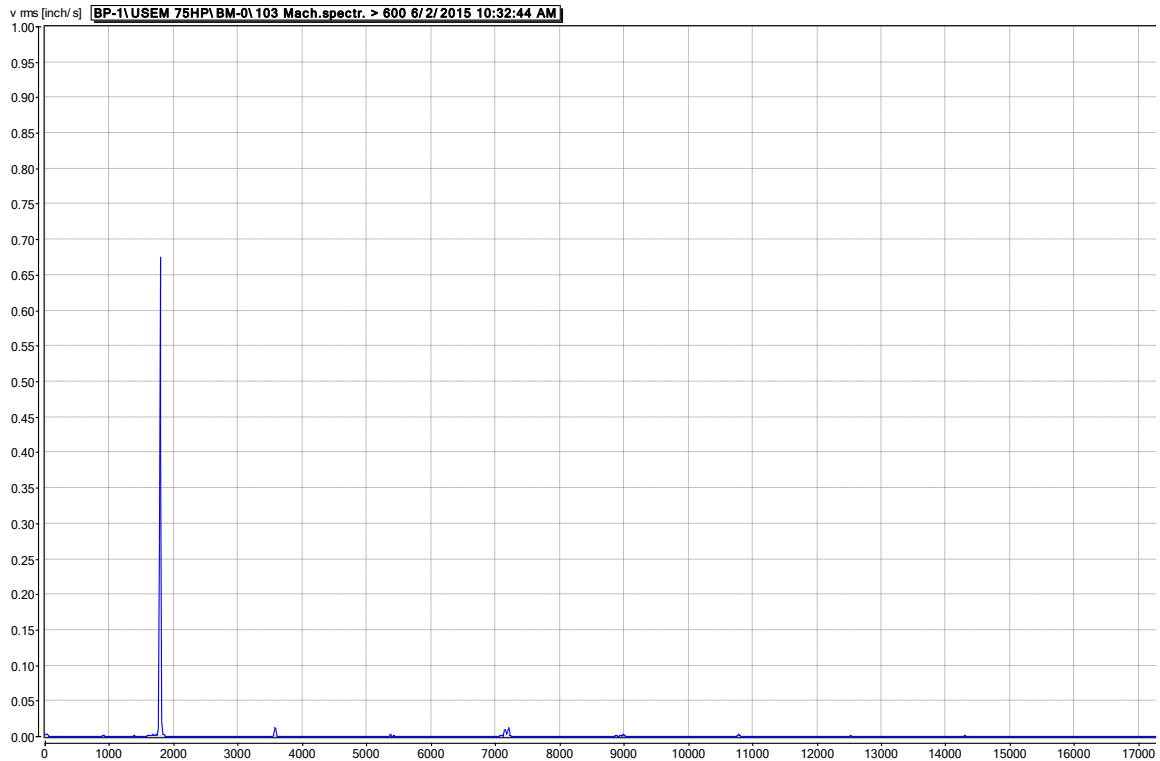
Figure 11: MB-0 Filtered Vibration, highest peak is 0.675 in/sec at 1,788 cpm (1X run speed)
